# VEHICLE INSPECTION REPORT

**YF71GVR**

## Maxus Deliver 3

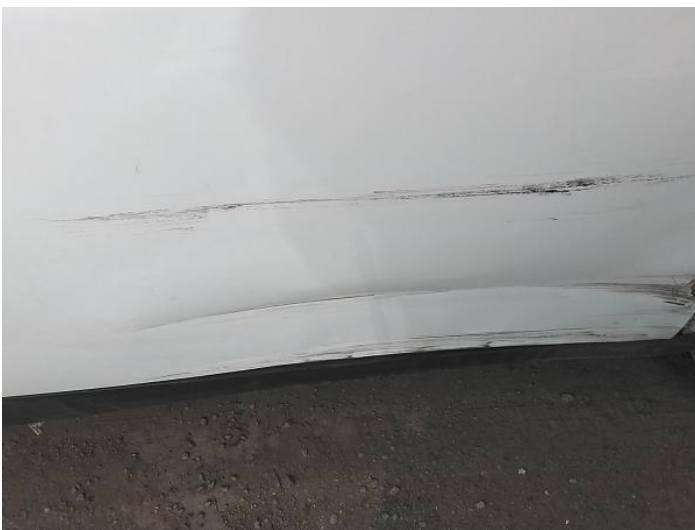
7: Qtr Panel nsr  
Dented  
With Paint Damage

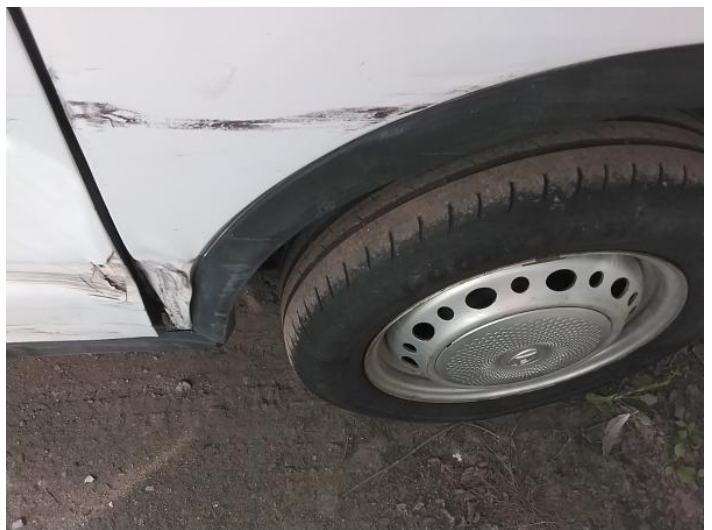
8: Qtr Panel nsr  
Dented  
With Paint Damage

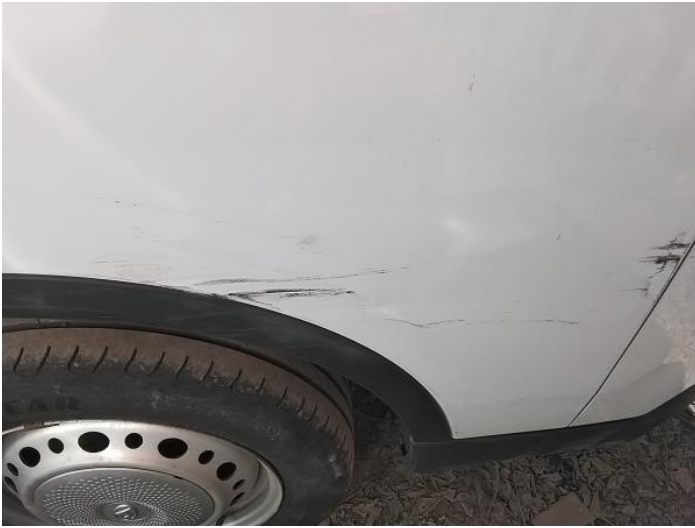
9: Qtr Panel nsr  
Dented  
With Paint Damage

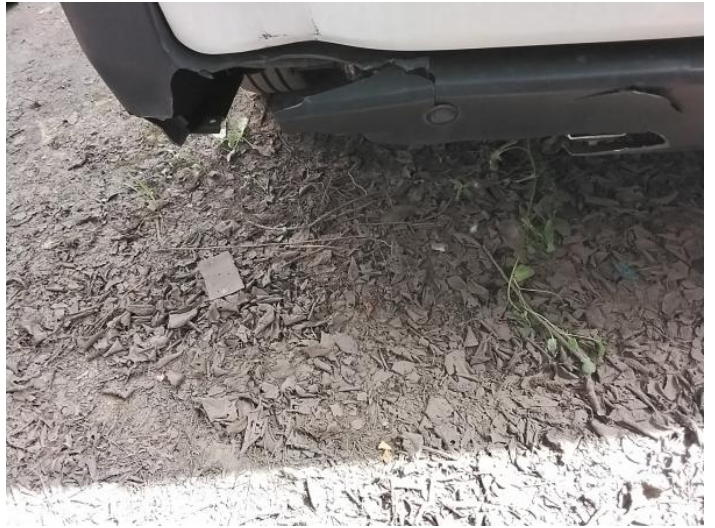
10: Bumper Rear  
Cracked  
Over 25mm

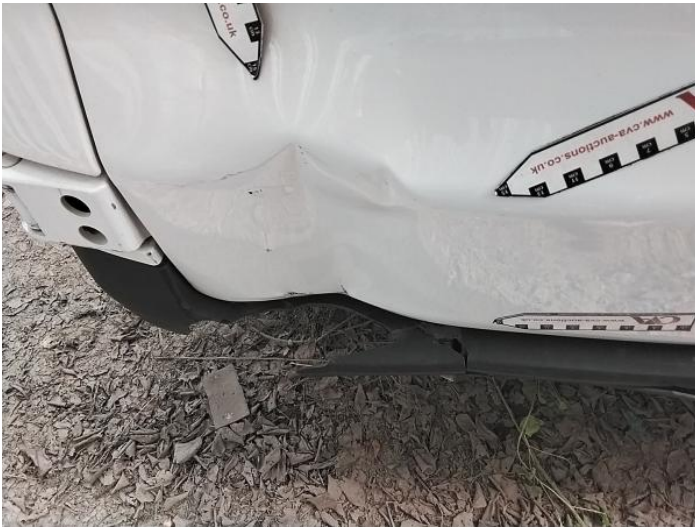
11: Door nsr  
Dented  
With Paint Damage

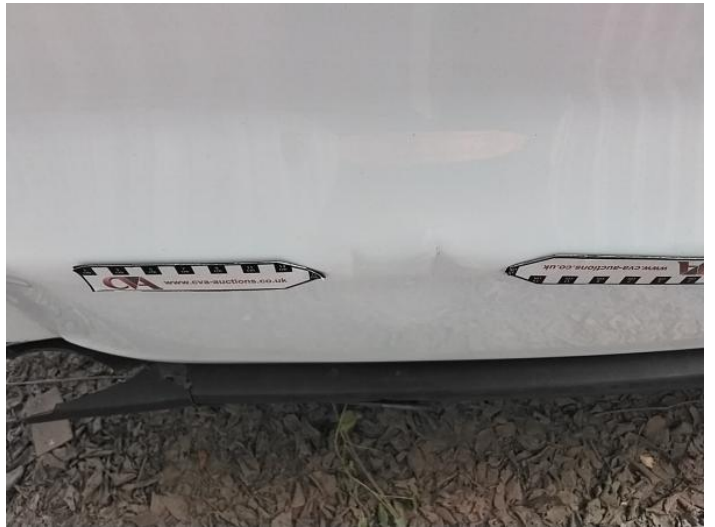
12: Door nsr  
Dented  
With Paint Damage

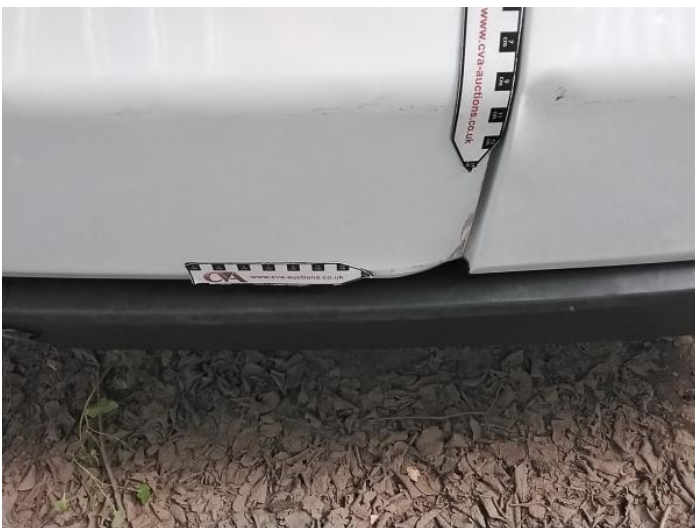
13: Door nsr  
Dented  
With Paint Damage

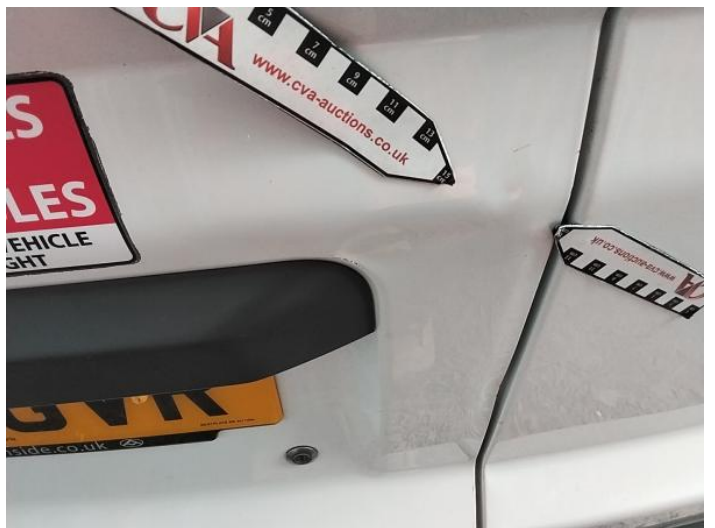
14: Door nsr  
Dented  
Over 30mm
